**CITY OF NORTH ST. PAUL  
CITY COUNCIL  
WORKSHOP AGENDA  
APRIL 17, 2018  
5:00 PM**

**COUNCIL WORKSHOP**  
**2018 STREET AND UTILITY IMPROVEMENT PROJECT – LAKE BOULEVARD**  
**ALTERNATIVES**

## ***Technical Memorandum***

**Re:** *Pavement Coring Forensic Report*  
*WSB Project Number: 011470*

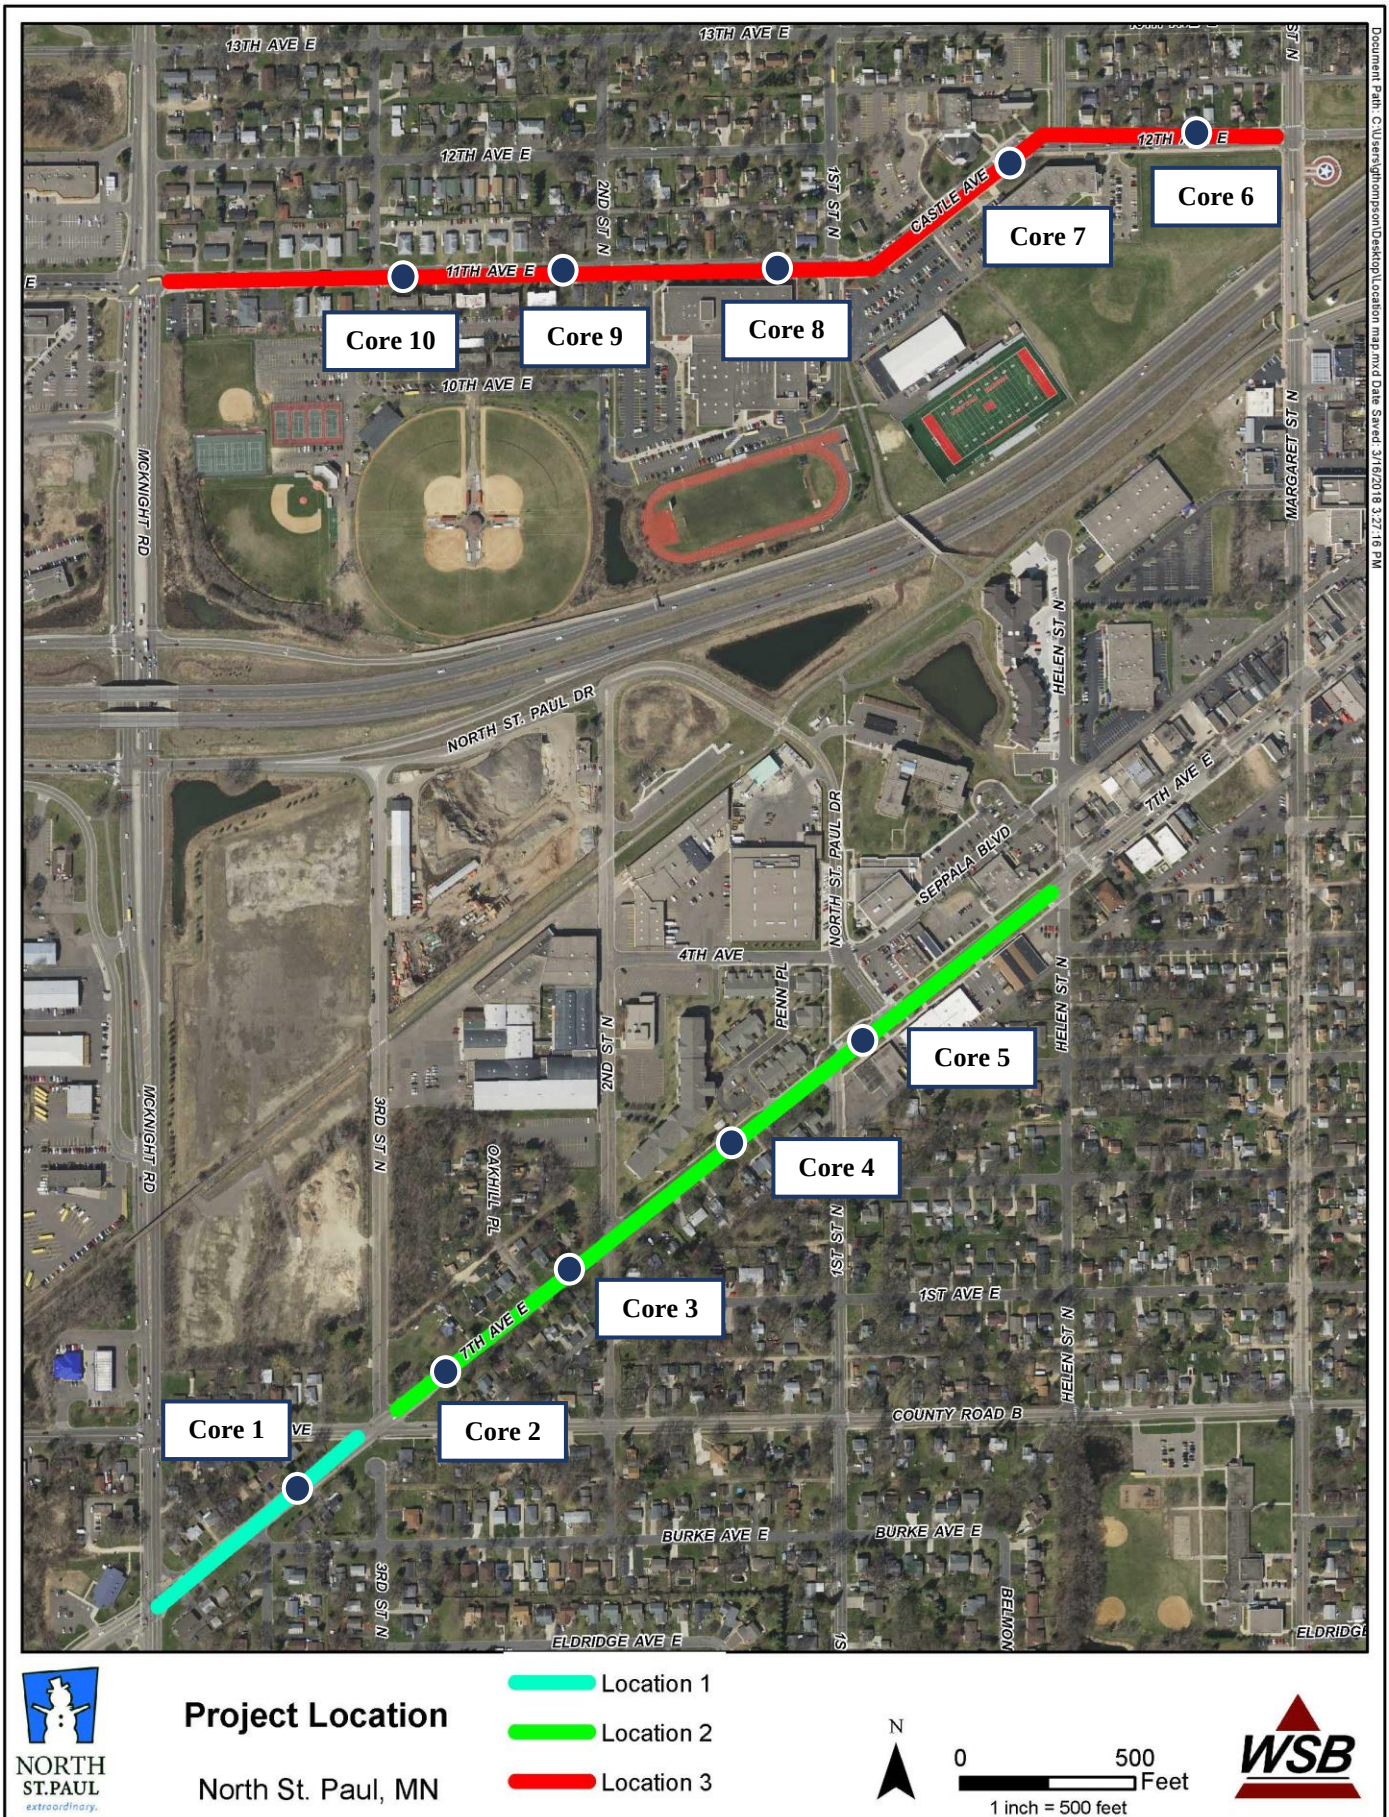
Figure 1. Pavement core locations taken within the City of North St. Paul.

A total of 10 pavement cores were taken within the roadway segments. The locations of the pavement cores are summarized in **Figure 1** below and a summary of the pavement depths and conditions are shown on **Table 1** below. Recommended maintenance activity for each Project Location are summarized in **Table 2** below. Pictures of the pavement cores and roadway surface are shown in **Appendix A** of this report.

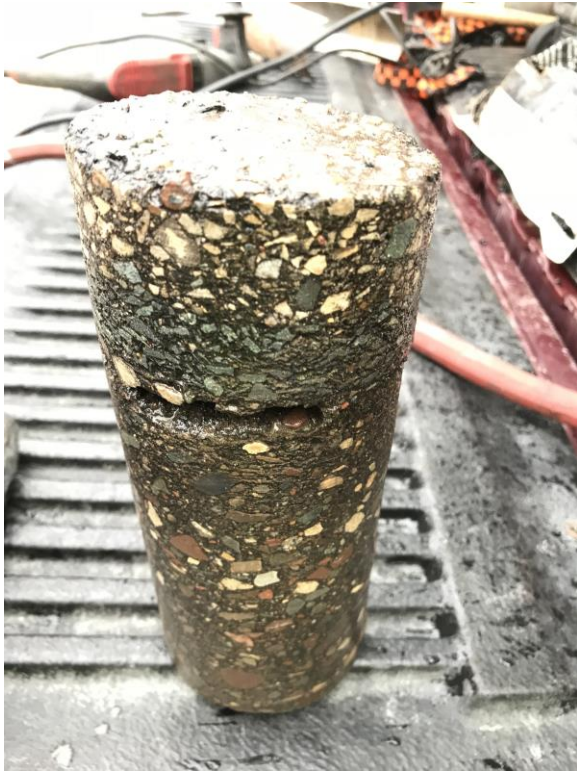
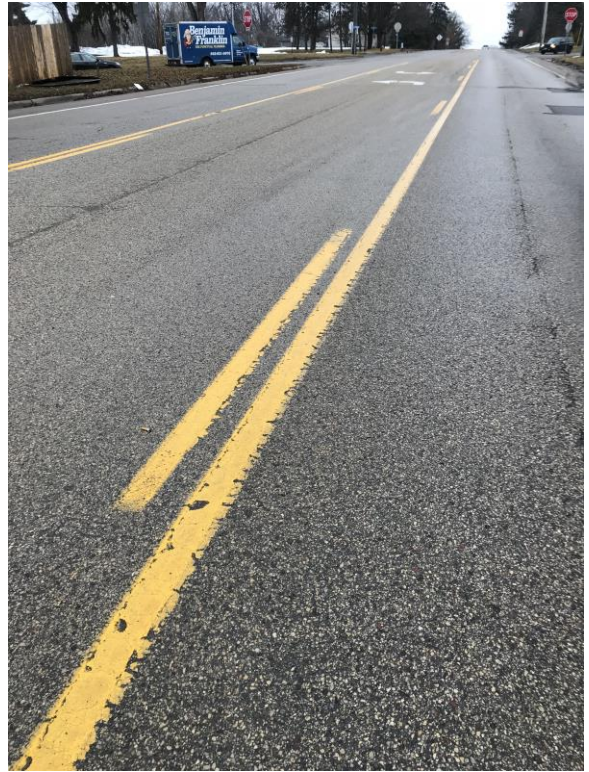
***Core 1: 7<sup>th</sup> Ave E (McKnight Rd to 3<sup>rd</sup> St N)***

| Core ID | Project Location | Street | Bituminous Depth (inches) | Aggregate Depth (inches) | Notes |
|---|---|---|---|---|---|
| 1 | 1 | 7 <sup>th</sup> Ave E<br>(McKnight Rd to 3 <sup>rd</sup> St N) | 9 | 7+ | 2.5" top lift delaminated from the remaining bottom of the core. |

One core was taken on 7<sup>th</sup> Ave E from McKnight Rd to 3<sup>rd</sup> St N. The core had a bituminous depth of 9 inches and there was at least 7 inches of gravel found underlying the bituminous. The top 2.5 inches of the bituminous was delaminated from the bottom of the core. The street was observed to be in fair condition with fatigue cracking and some spots of patching. It would be our recommendation to perform a SFDR that will help increase the structural strength of the pavement. For this section, it would be our recommendation to mill off 4 inches of bituminous, grind the remaining 5 inches of bituminous with 1 inch of gravel, and stabilize the 6-inch mixture, followed by repaving 3 inches to 4 inches of bituminous. SFDR is estimated to cost around \$23.00 per square yard including cost of pre-grind and engineered emulsion and assuming \$63 a ton for the HMA mix, with an extension of life of approximately 30 years.

| Core ID | Project Location | Street | Recommended Maintenance Activity |
|---|---|---|---|
| 1 | 1 | 7 <sup>th</sup> Ave E<br>(McKnight Rd to 3 <sup>rd</sup> St N) | SFDR |

A mill and overlay with an Ultra-Thin Bonded Wearing Course (UTBWC) can also be an option for maintenance. The milling depth should be deeper than where the delamination between lifts occurred, which is greater than 2.5 inches. This is to ensure good bonding between the bituminous lifts by removing the existing delamination. Cracks will likely reflect through the new pavement within a few years and this technique provides roughly a 10-year fix. It is estimated that a 3-inch mill and a 2.25-inch overlay with UTBWC to cost around \$14.15 per square yard, not including the milling cost and assuming \$63 a ton for HMA mix.

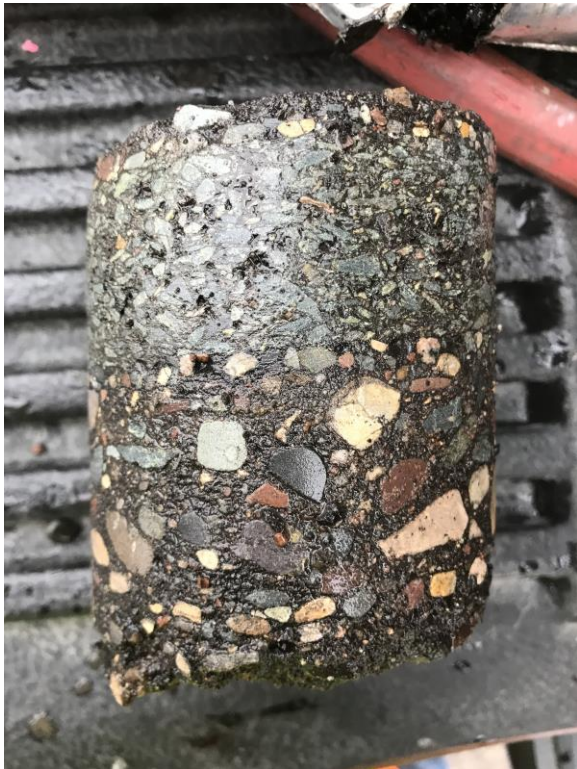
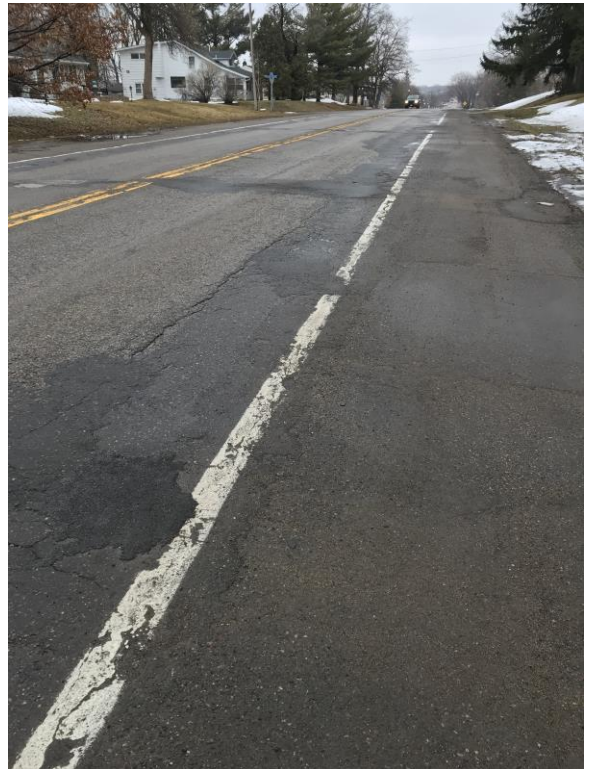
***Core 2: 7<sup>th</sup> Ave E (3<sup>rd</sup> St N to 2<sup>nd</sup> St N)***

| Core ID | Project Location | Street | Bituminous Depth (inches) | Aggregate Depth (inches) | Notes |
|---|---|---|---|---|---|
| 2 | 2 | 7 <sup>th</sup> Ave E<br>(3 <sup>rd</sup> St N to Oakhill Pl) | 4.5 | Concrete | Two 1" Type 61 lifts. Type 61 mixture observed to have large voids. Core showed signs of deterioration, losing fines and binder. |

Core #2, #3, and #4 were taken on 7<sup>th</sup> Ave E from 3<sup>rd</sup> St N to 1<sup>st</sup> St N, with bituminous depths ranging from 4.5 inches to 6 inches. The top lifts of the core were observed to be made up of two 1-inch Type 61 mixes with large voids. Type 61 mixes are old asphalt mixes under Section 2331 in the *MnDOT Standard Specifications for Construction 2000*. All cores showed signs of deterioration, with cores losing fines and binder throughout. Concrete pavements were found underneath the bituminous layers in these core locations. These bituminous pavements were in poor condition with the surface highly raveled and spots of patching and alligator cracking along the street.

| Core ID | Project Location | Street | Recommended Maintenance Activity |
|---|---|---|---|
| 2 | 2 | 7 <sup>th</sup> Ave E<br>(3 <sup>rd</sup> St N to Oakhill Pl) | Full depth bituminous removal with UTBWC followed by an overlay |

It would be recommended to perform a full depth bituminous removal and replacement, with an UTBWC as an interlayer. UTBWC can act as a bond breaker between the existing concrete pavement and the new bituminous overlay that will help retard the deterioration of cracks. Thus, the new pavement would only need a 1.5-inch to 2-inch bituminous lift leveled, which costs roughly \$13.25 per square yard including UTBWC. However, concrete curbs were observed along the Westbound lane of 7<sup>th</sup> Ave E from 2<sup>nd</sup> St N to 1<sup>st</sup> St N and they were in good condition, while bituminous curbs were found along the Eastbound lane. It would be recommended to pave full depth bituminous, approximately 5 inches, so that it matches with the concrete curbs. It is estimated this would cost \$24.00 per square yard including the UTBWC. This type of repair will provide a 10-year to 15-year of fix. Full depth removal and replacement of 6-inch bituminous pavement without an UTBWC is estimated to cost around \$21.75 per square yard. It is important to note that the cracks will reflect through within a few years. The costs above were calculated assuming \$63 a ton for HMA mix and they do not include milling cost.

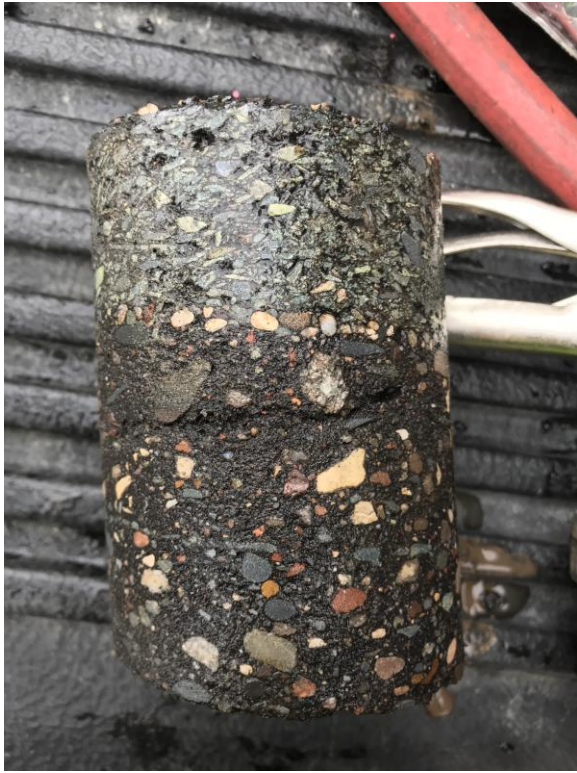
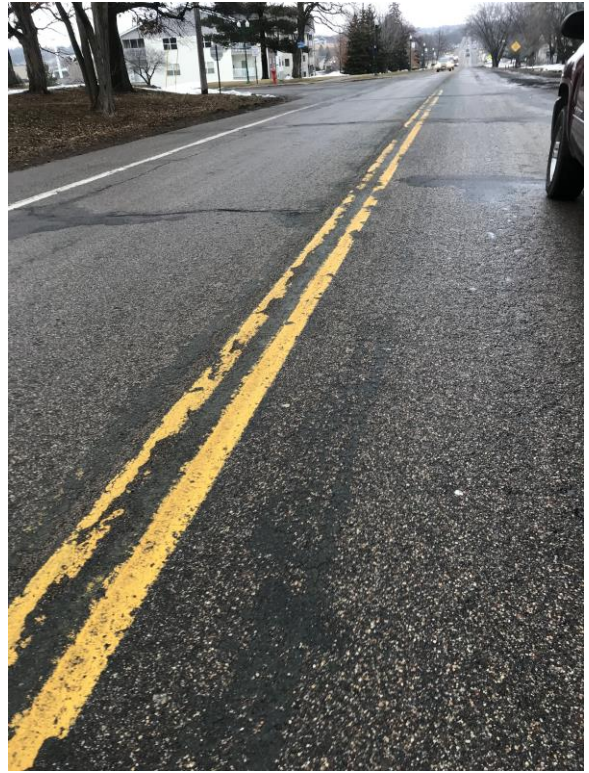
***Core 3: 7<sup>th</sup> Ave E (3<sup>rd</sup> St N to 2<sup>nd</sup> St N)***

| Core ID | Project Location | Street | Bituminous Depth (inches) | Aggregate Depth (inches) | Notes |
|---|---|---|---|---|---|
| 3 | | 7 <sup>th</sup> Ave E<br>(Oakhill Pl to 2 <sup>nd</sup> St N) | 5.25 | Concrete | Two 1" Type 61 lifts. Type 61 mixture observed to have large voids. Core showed signs of delamination. |

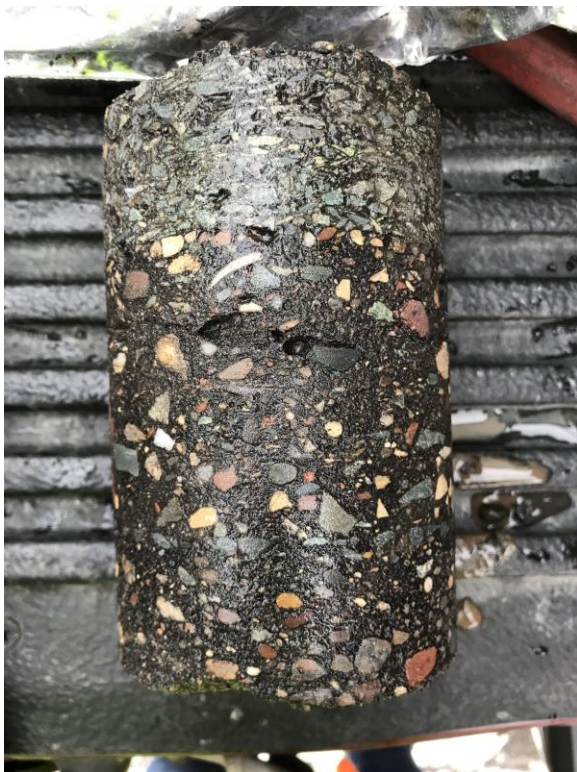
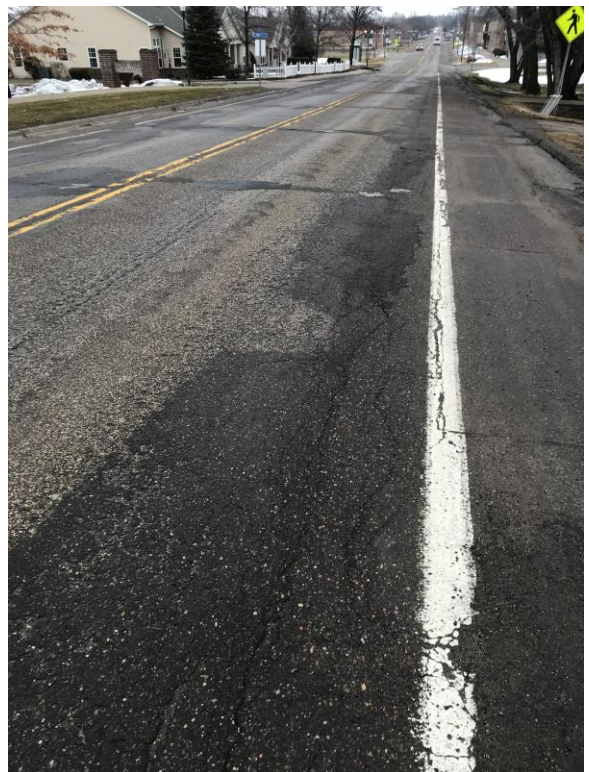
***Core 4: 7<sup>th</sup> Ave E (2<sup>nd</sup> St N to 1<sup>st</sup> St N)***

| Core ID | Project Location | Street | Bituminous Depth (inches) | Aggregate Depth (inches) | Notes |
|---|---|---|---|---|---|
| 4 | | 7 <sup>th</sup> Ave E<br>(2 <sup>nd</sup> St N to 1 <sup>st</sup> St N) | 6 | Concrete | Two 1" Type 61 lifts. Type 61 mixture observed to have large voids. Core showed signs of deterioration, losing fines and binder. |

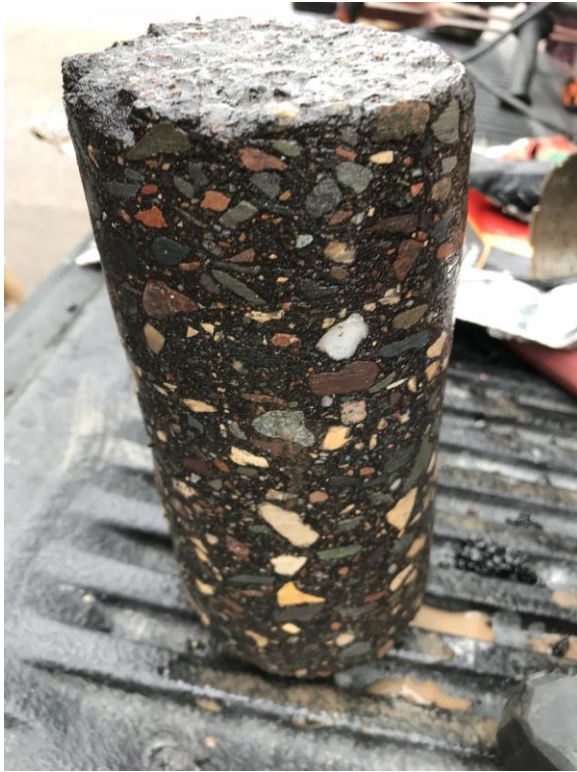
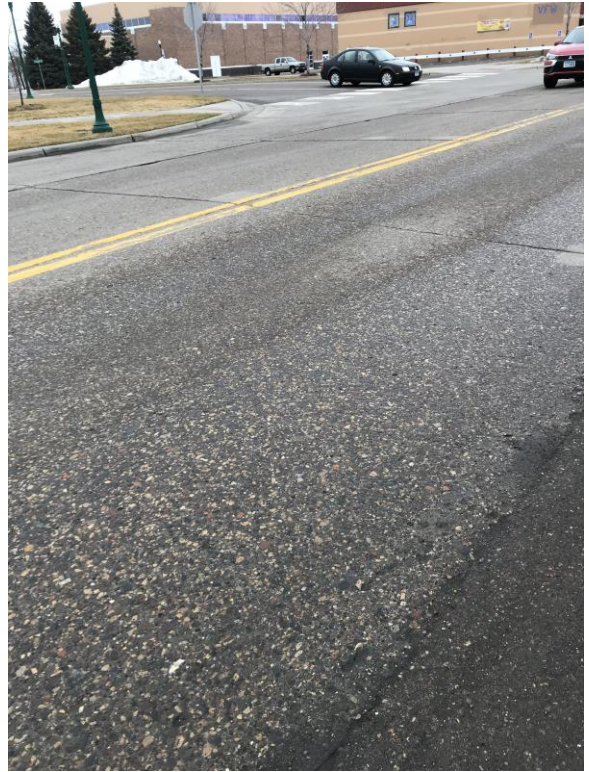
***Core 5: 7<sup>th</sup> Ave E (1<sup>st</sup> St N to North St. Paul Dr)***

| Core ID | Project Location | Street | Bituminous Depth (inches) | Aggregate Depth (inches) | Notes |
|---|---|---|---|---|---|
| 5 | | 7 <sup>th</sup> Ave E<br>(1 <sup>st</sup> St N to North St. Paul Dr) | 7.5 | 8+ | Driving lane is concrete pavement. Core was taken on the shoulder EB. Core was in good condition. Curbs were observed to be in good condition. Sandy Class 5 material was found underneath bituminous. |

One core was taken along 7<sup>th</sup> Ave E from 1<sup>st</sup> St N to North St. Paul Dr. The driving lane was concrete pavement thus the core was taken on the Eastbound shoulder. The core had a depth of 7.5 inches with a top

lift of 1.5 inches, and it was in good condition. The curbs were also in good condition so curb replacement is not anticipated anytime soon. It would be recommended to perform a fog seal along the bituminous shoulder to protect the pavement surface from oxidation. Fog sealing is estimated to cost approximately \$.50 per square yard. The core was not taken along 7<sup>th</sup> Ave E East of North St. Paul Drive since the street was observed to be concrete pavement.

| Core ID | Project Location | Street | Recommended Maintenance Activity |
|---|---|---|---|
| 5 | | 7 <sup>th</sup> Ave E<br>(1 <sup>st</sup> St N to North St. Paul Dr) | Fog seal (shoulder) |

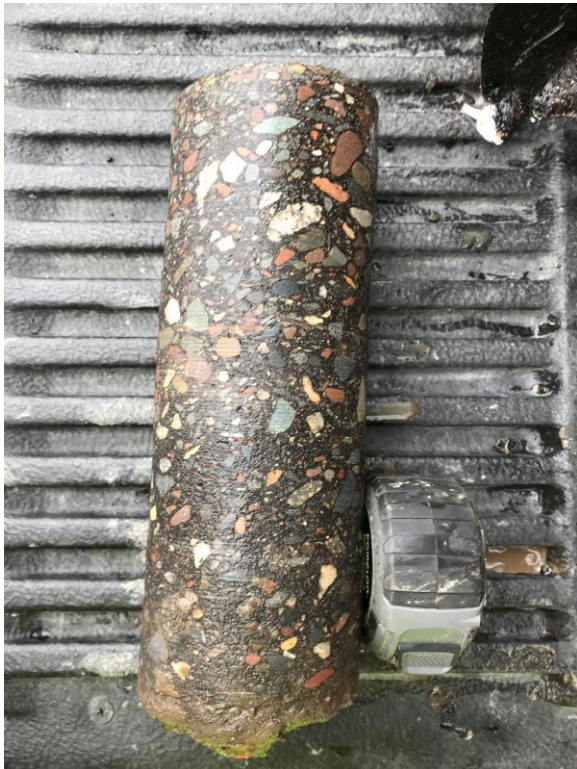
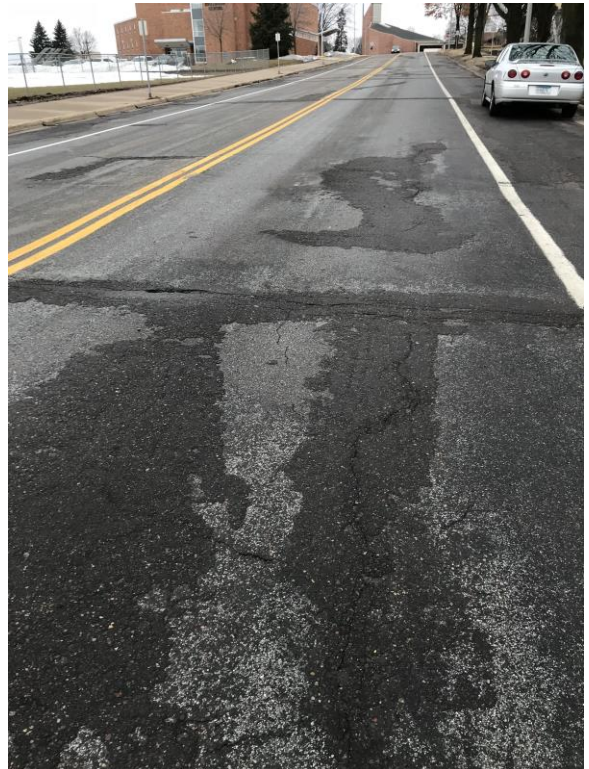
***Core 6: 12<sup>th</sup> Ave E (Helen St N to Margaret St N)***

| Core ID | Project Location | Street | Bituminous Depth (inches) | Aggregate Depth (inches) | Notes |
|---|---|---|---|---|---|
| 6 | 3 | 12 <sup>th</sup> Ave E (Helen St N to Margaret St N) | 10 | 6+ | 2.5" top lift and core was in good condition. Base layer was observed to be sandy Class 5 material with traces of silt. |

Core #6 taken on 12<sup>th</sup> Ave E had a bituminous depth of 10 inches, with a top lift of 2.5 inches. The core was in good condition and the underlying aggregate base was found to be at least 6 inches of sandy Class 5 material with traces of silt. The road surface was in poor condition, with high severity alligator cracking and large areas of patching, hence we would not recommend a mill and overlay on this street. We do not have traffic information, but from observing there is heavier bus traffic around the area and silt material found, it would be recommended to perform a SFDR to increase the structural capacity of the pavement. On 12<sup>th</sup> Ave E, we would recommend milling off 4 inches of bituminous, grinding the remaining 6 inches of asphalt with 1 inch of gravel, stabilizing 6 inches of the reclaimed material, followed by repaving 3 inches to 4 inches of bituminous.

| Core ID | Project Location | Street | Recommended Maintenance Activity |
|---|---|---|---|
| 6 | 3 | 12 <sup>th</sup> Ave E (Helen St N to Margaret St N) | SFDR |

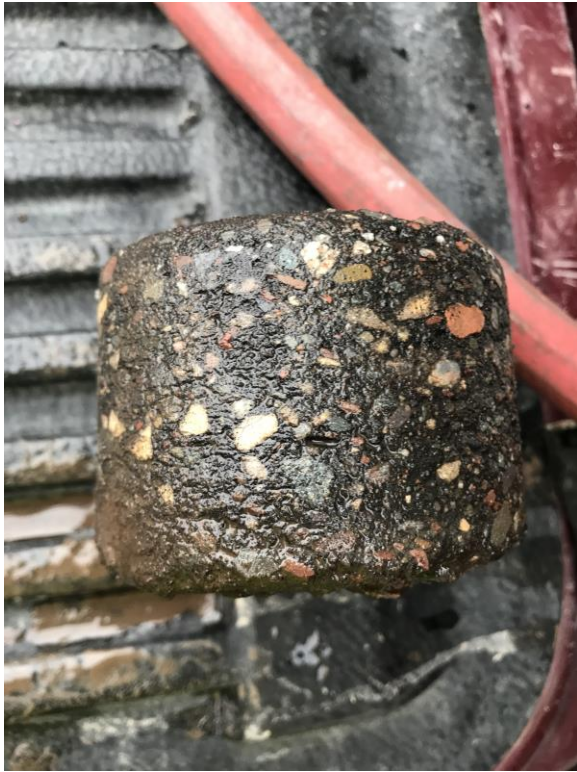
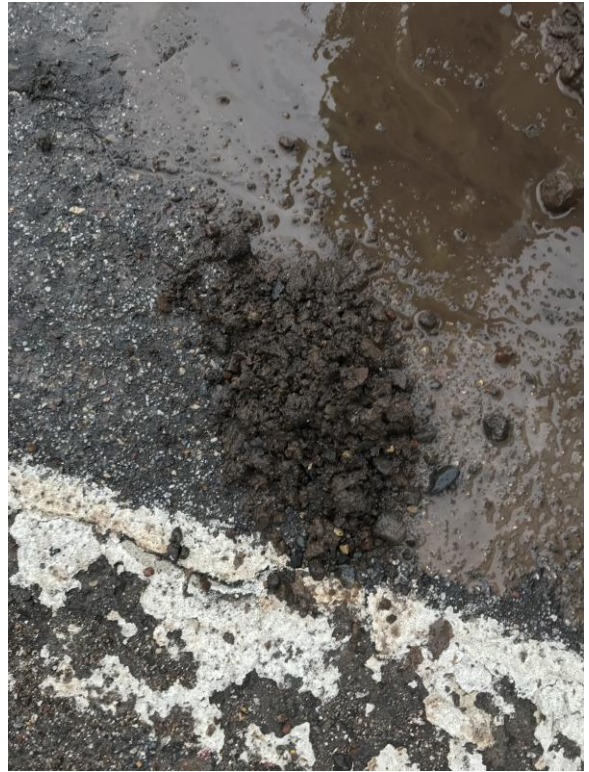
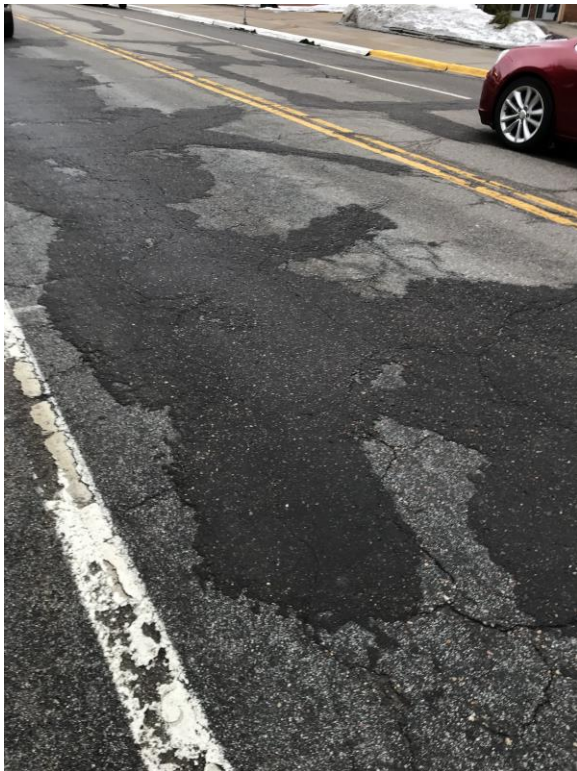
***Core 7: Castle Ave E (1<sup>st</sup> St N to Helen St N)***

| Core ID | Project Location | Street | Bituminous Depth (inches) | Aggregate Depth (inches) | Notes |
|---|---|---|---|---|---|
| 7 | | Castle Ave (1 <sup>st</sup> St N to Helen St N) | 7 | 7+ | 2.5" top lift and the bottom of the core crumbled into pieces. The core showed signs of deterioration. |

Core #7 was taken on Castle Ave with a bituminous depth of 7 inches. The core extracted measured only 2.5 inches, as the bottom 4.5 inches had crumbled into pieces. There was at least 7 inches of gravel underneath the bituminous layer. Core #8, #9, and #10 were taken along 11<sup>th</sup> Ave N from 3<sup>rd</sup> St N to 1<sup>st</sup> St N, with bituminous depths ranging from 5 inches to 6 inches. The bottom of all cores were found to be crumbled to pieces. During the coring operation, all the cores obtained along Castle Ave and 11<sup>th</sup> Ave N were highly raveled at the bottom; thus, we could not obtain the depths of pavement by just measuring the core thicknesses since the bituminous had crumbled into pieces. We determined the bituminous depths by measuring along the wall of the core holes, until the material changed to aggregate base. There was at least 6 inches of gravel underlying the bituminous pavement. It would be recommended to mill off 4 inches of the bituminous pavement, and grind and stabilize the remaining bituminous and gravel with varying depth, with a total stabilization depth of 6 inches, followed by repaving 4 inches of bituminous. SFDR for this street is estimated to cost around \$23.00 per square yard including cost of pre-grind and engineered emulsion and assuming \$63 a ton for HMA mix, with an extension of life for approximately 30 years. Curb repair should be conducted where it is determined to be necessary.

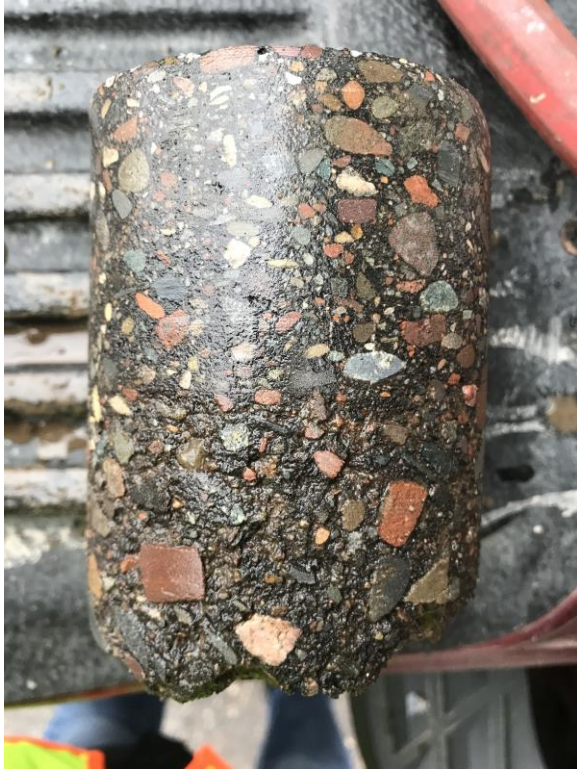
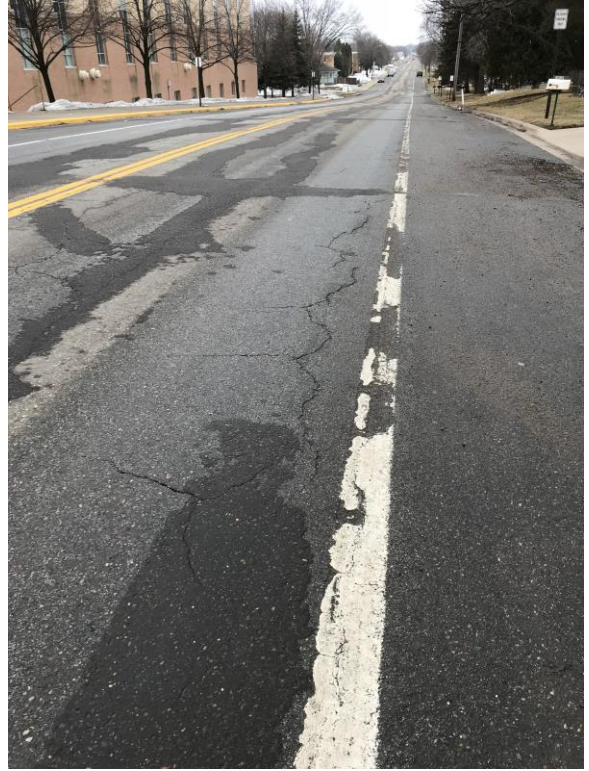
***Core 8: 11<sup>th</sup> Ave E (2<sup>nd</sup> St N to 1<sup>st</sup> St N)***

| Core ID | Project Location | Street | Bituminous Depth (inches) | Aggregate Depth (inches) | Notes |
|---|---|---|---|---|---|
| 8 | | 11 <sup>th</sup> Ave E (2 <sup>nd</sup> St N to 1 <sup>st</sup> St N) | 6 | 6+ | Core was measured to be 5" thick, bottom 1" crumbled into pieces. Top lift of the core was in good condition, bottom lift showed signs of deterioration. |

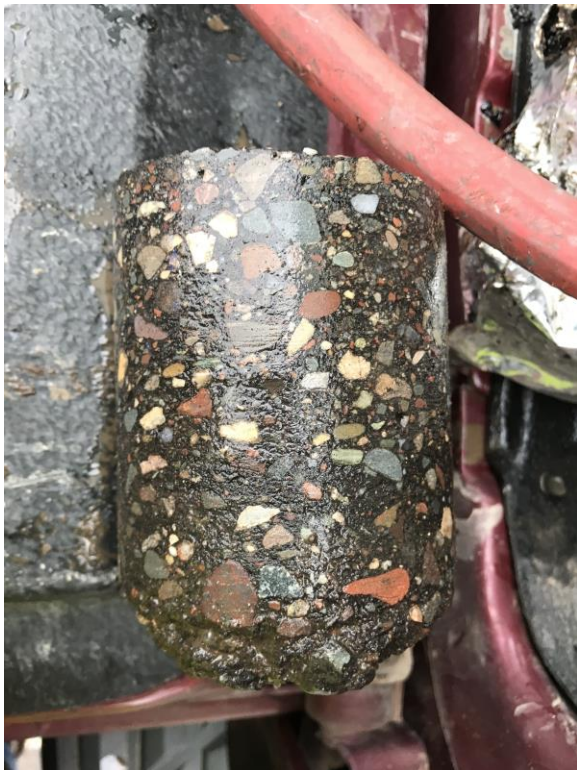
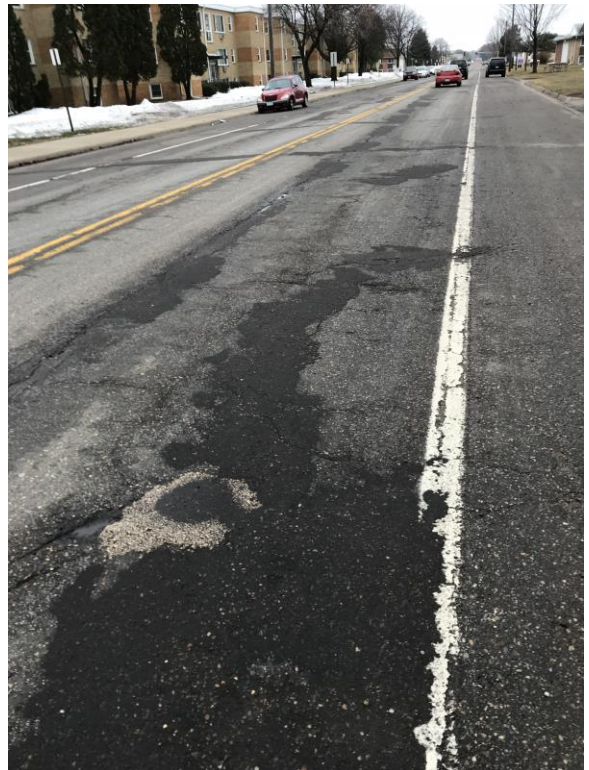
***Core 9: 11<sup>th</sup> Ave E (3<sup>rd</sup> St N to 2<sup>nd</sup> St N)***

| Core ID | Project Location | Street | Bituminous Depth (inches) | Aggregate Depth (inches) | Notes |
|---|---|---|---|---|---|
| 9 | | 11 <sup>th</sup> Ave E (3 <sup>rd</sup> St N to 2 <sup>nd</sup> St N) | 6 | 6+ | Core was measured to be 5" thick, bottom 1" crumbled into pieces. Top lift of the core was in good condition, bottom lift showed signs of deterioration. |

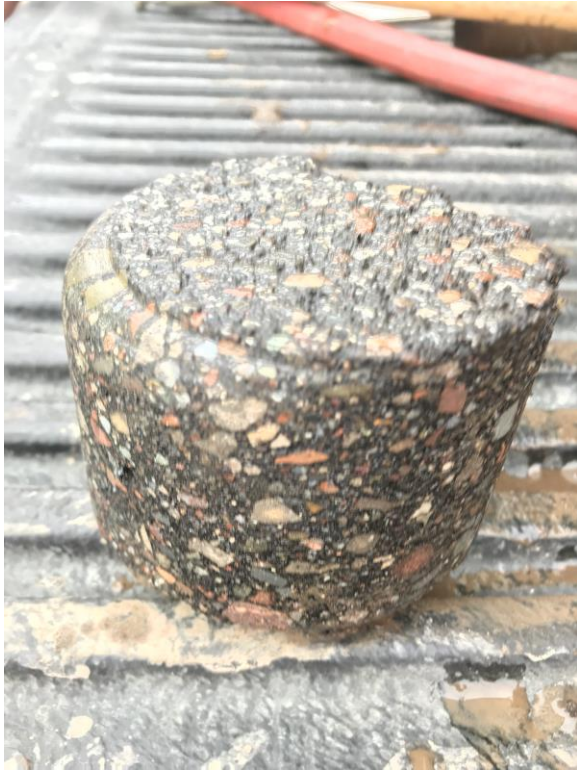
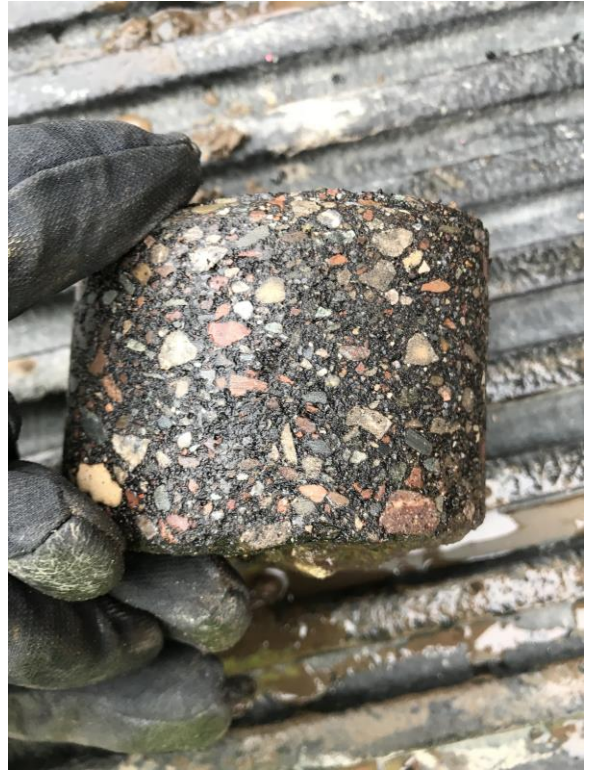
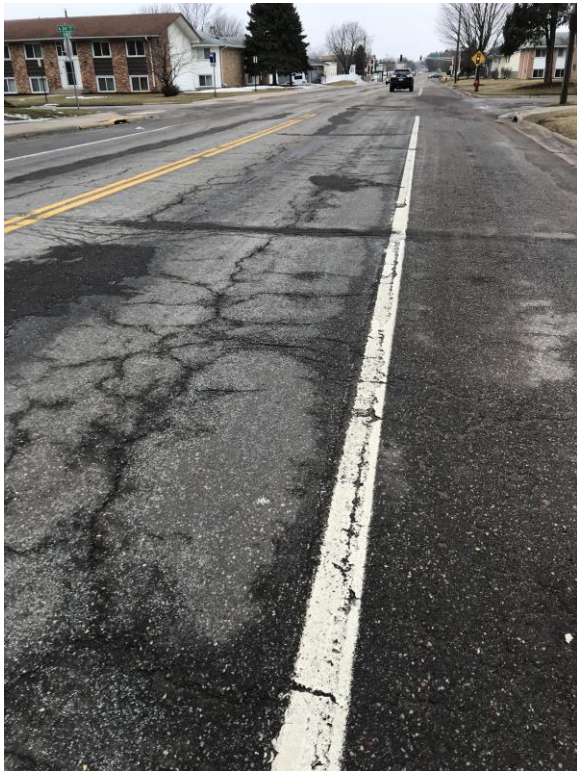
***Core 10: 11<sup>th</sup> Ave E (3<sup>rd</sup> St N to 2<sup>nd</sup> St N)***

| Core ID | Project Location | Street | Bituminous Depth (inches) | Aggregate Depth (inches) | Notes |
|---|---|---|---|---|---|
| 10 | | 11 <sup>th</sup> Ave E (3 <sup>rd</sup> St N to 2 <sup>nd</sup> St N) | 5 | 6+ | Core was measured to be 2.5" thick, bottom half crumbled into pieces. Core showed signs of deterioration. |
